## **ANALYSIS OF BRITTLE FAILURE OF PRESTRESSED BRIDGE IN THE NORTH OF SLOVAKIA**

Martin MORAVČÍK, Petra BUJŇÁKOVÁ  
University of Žilina, Faculty of Civil Engineering, Žilina, Slovakia

This paper is focused on the primary causes of failures and collapse state of the concrete bridge superstructure which is located on the international route I/59 connecting Slovakia with Poland (bridge No. 59-090). Dangerous structural defects of brittle character were found in four girders of the bridge structure during the routine inspection in 2015. Subsequently, the object was declared as being in the emergency status and immediately closed for the traffic at the end of 2015. This bridge was built in 1956 as one of the first generation of the precast and prestressed structures in Czechoslovakia.

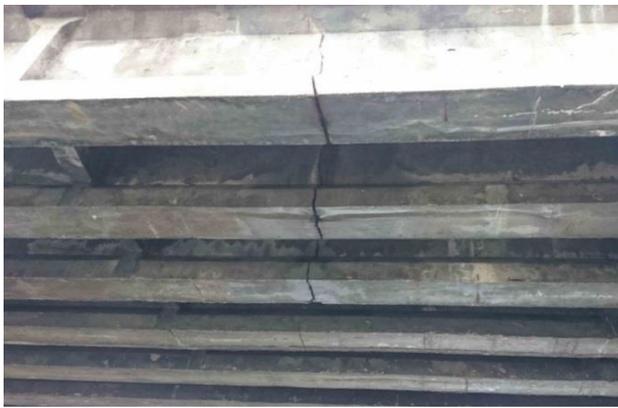
The brittle failure had been raised at the right edge of the bridge in the second span. There was found out that 4 girders were totally broken. A critical crack in the middle section with several centimeters width was discovered. It had been formed almost in the entire cross-sectional height (see Fig. 4). Also the deformation of the right part of the bridge deck was visible, and that effect was accompanied by the excessive oscillation of the structure as the heavy trucks were passing through the bridge. The character of isolated wide crack in the middle cross-section was as a textbook example of brittle bending failure of concrete member. No other traditional distributed bending cracks were recorded. But at the same time, there were detected visible overloading and gradually developing cracks in the centre of span on remaining 6 girders. These beams were overloaded by the traffic and self-weight of the broken girders.

Fig. 4a. Brittle failure on the 4 edge girders.

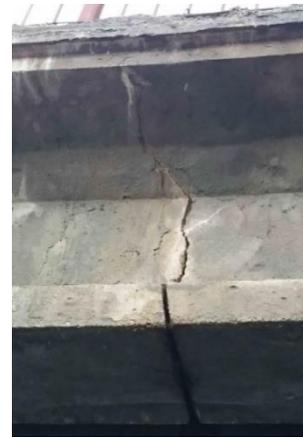
Fig. 4b. Detail of the primary crack.

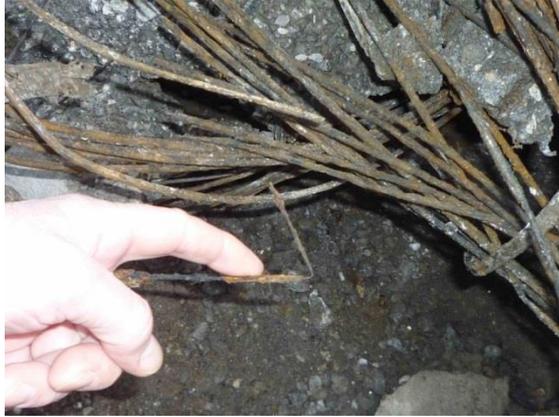
During the demolition work the main cause of the collapse was step by step detected. Many of the prestressing wires with parabolic course were corroded in the center of the span (see Fig. 5a) because water in the ducts was concentrated just in the middle cross-section due to the fact that some of them (around 50 %) have not been protected, and next ones have very poor concrete protection in the anchor zone (see Fig. 5b). Additionally, around 90% of the ducts were not grouted. There were the total number of 44 anchors, and 16 anchors were anchored on the top flange of the girder under the leveling concrete layer of the pavement. That fact greatly accelerated water flow to the middle cross-section and the corrosive action of the water in the ducts.

Beside loss of prestressing, there was the next negative moment of the brittle character of collapse. It was total absence of the standard reinforcement. Underestimation of conventional reinforcement was around 85 % comparing to the European standard requirements [1]. All those causes confirmed the assumption of the low ductility of the prestressed girders and the prediction of the brittle character of the collapse. However, the characteristic strength of the concrete achieved quite high values from 49 to 52 MPa, and it could be seemingly assessed visually as being in good condition. We can call this fact as a “time bomb” in the concrete structure.

Fig. 5a. Corroded wire pulled out from the duct.

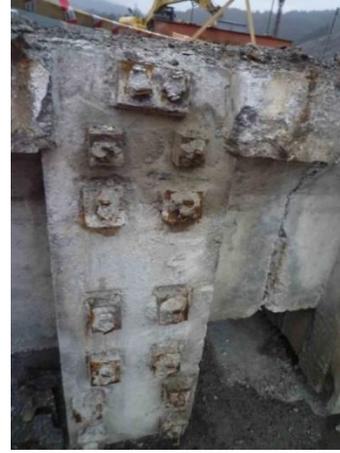
Fig. 5b. Anchorage zone.

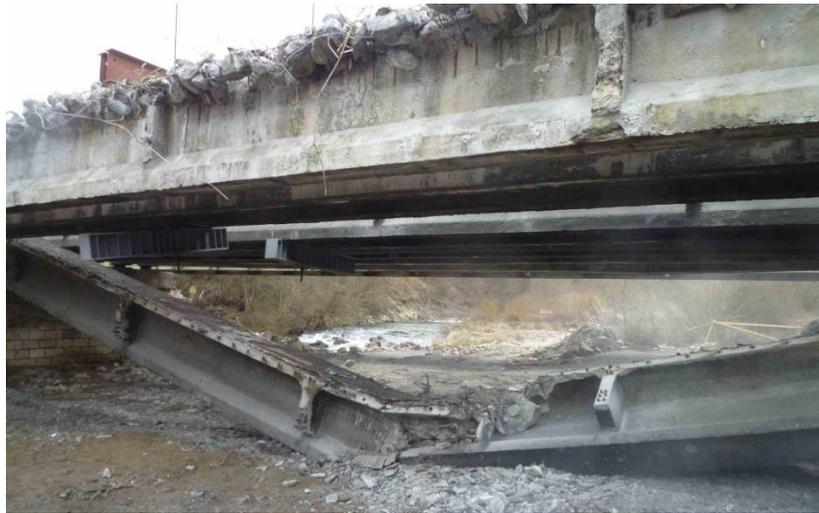
Fig. 5c. Falling down girder during demolition works.

The transverse prestressing consisted of 11 wires  $\phi$  P 4.5 mm and was relatively functional and even partially grouted. That fact essentially ensured that no fatal event had been occurred to that time on the bridge. This was evidenced because, after cutting transverse wires, all damaged girders felt down (see Fig. 5c). They could not be able to carry their self-weight.

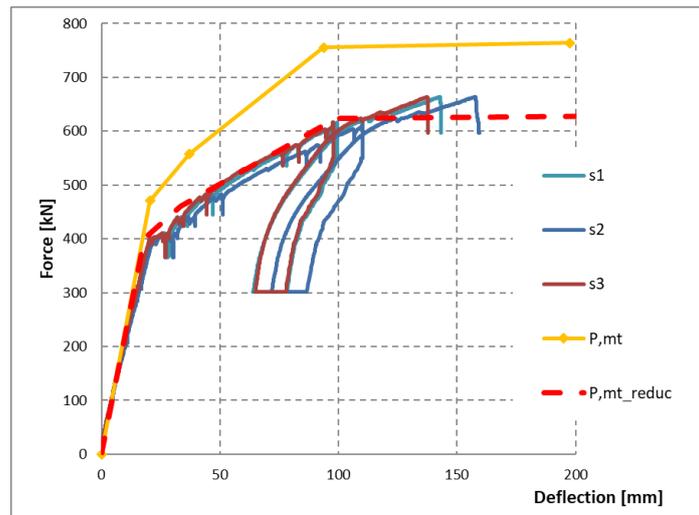
During the demolition works on the superstructure, the static load test was performed in situ. For that purpose, there was selected one girder in relatively good condition in comparison to the others which still acted on the abutments. Three sensors (s1-s3) were installed in the middle section to monitor the deflection during the test. As a load member the hydraulic jack with 100 tons (1000 kN) capacity was used. The total load 65 tons was reached. However, actual ultimate limit state occurred under load 60.5 tons. It represents a reduction of about 20 % compared to the assumed load capacity (around 75 tons, curve  $P_{,mt}$ , see Fig. 6). The first crack was discovered on a load level about 40 tons. It is apparent also

from Fig. 6. The calculated value was estimated on the level around 48 tons, so it represents reduction around 17 %. It can be seen that the course of the theoretical and actual deflection begins to be different significantly after the first crack being formed. About 30 % lower level of prestressing was the reason of such load capacity and smaller ductility. It was derived by the reverse iterative calculation based on the girder stiffness according to Fig. 6. Assumed prestressing reduction, at the other girders in worse condition more than 50 %, can be considered.

Fig. 6. Load vs. deflection diagram.
