THE PROBLEM OF SCAFFOLDS FAILURES DURING THE CONSTRUCTION OF NEW VIADUCT OVER HIGHWAY

Daniel KAŁUZIŃSKI ¹⁾, Zbigniew MAŃKO ²⁾, Arkadiusz MORDAK ³⁾

Using as example highway viaducts WD-14 and WD-12 built over national road A-18 being upgraded, the failures of the scaffolds erected to build on site the concrete objects are described and their causes are explained. The cases considered here and the ones presented previously [1, 3, 4, 5, 8, 9, 22] clearly show the need to modify and update the guidelines for erecting scaffolds for the building of road bridge structures. This applies particularly to the minimum headroom as vertical clearance since the current standard one is inadequate. The above considerations should be taken into account in the designs of bridge structures.

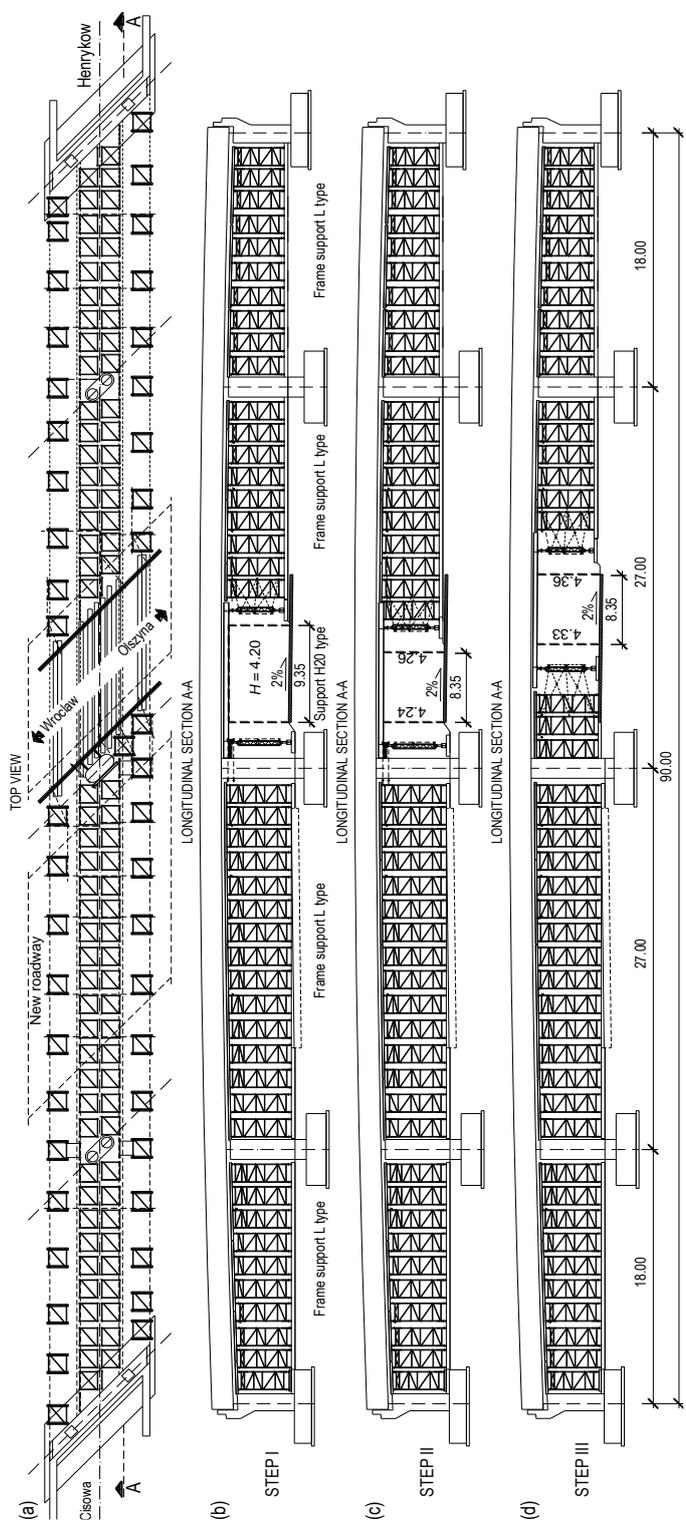
Fig. 3. Arrangement of EngelhardRöRo scaffolds for viaduct WD-14: (a) top view, (b) longitudinal section A-A (vertical clearance 4.20 m), (c) longitudinal section A-A (vertical clearance 4.24 m), and (d) longitudinal section A-A (vertical clearance 4.33 m).

The first alteration in the height of the drive-through clearance under the load-bearing girders of the scaffold was made by replacing the HE 360-B girders (10 units) with 16 girders of the HE 300-B type because of which the spacing of the main H200 girders decreased from 9.35 m to 8.35 m. In this way, a vertical clearance of 4.26 m was obtained. It was thought that there would be no more collisions (Fig. 3c).

After the second vehicle had stricken into the increased from 4.20 m to 4.26 m vertical clearance, it became necessary for safety reasons to redesign the height of the drive-through gate. A detailed analysis of the causes of the damage to the scaffold showed that replacing the HE-B 300 girders with shorter ones was out of the question because of the insufficient load-capacity of any shorter girders. It was found, however, that it was possible to reduce the height of the formwork trusses situated immediately above the clearance from 0.10 m to 0.06 m. In addition, because of the roadway cross fall of 2%, the whole drive-through gate was moved to the edge of the roadway towards the lowest road grade line whereby a few more reserve centimetres were obtained (Fig. 6). In this way, a vertical clearance of 4.33 m was obtained at the lowest point of the road 4.36 m at the edge of the clearance, i.e. by 0.13 m larger than the standard clearance of 4.20 m and by 0.07 m larger than the other clearance of 4.26 m (Fig. 3d). The new drive-through height of 4.33 m ensured safe work on the viaduct until its completion.

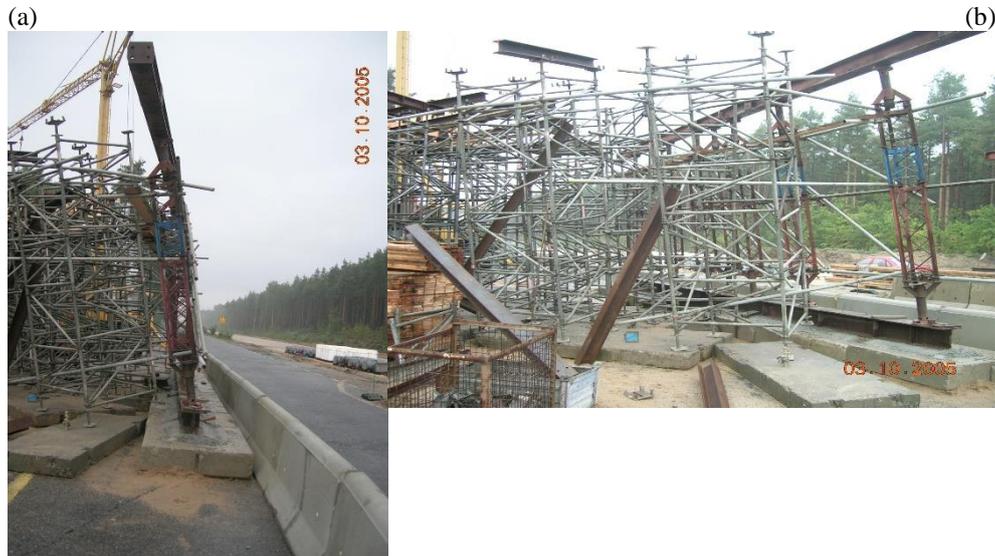
Fig. 4. View on the damaged scaffold supports in viaduct WD-14 after vehicle struck to the main girders located above drive-through clearance: (a) view from roadway, (b) side view.

During the construction of viaduct WD-14, the structural components of the scaffold near the drive-through clearance were damaged twice due to the too small standard headroom (insufficient for the proper location of scaffolds for the construction of bridge spans). The standard clearance is 4.20 m, and, in many cases, it no longer meets the current service conditions.

The first collision occurred on 29 September 2005. A TIR lorry (semi trailer height over 4.20 m) from Ukraine struck the scaffold, and, as a result, got stuck under the span seriously damaging the structural components of the scaffold. A few days later, on 3 October 2005 in the morning hours, a tractor-trailer unit transporting an excavator struck the scaffold components situated immediately above the clearance of viaduct WD-14. As a result, all the girders were knocked off and fell down onto the roadway (Fig. 4). Another strike of this vehicle into the scaffold of viaduct WD-12 caused two girders to turn (Fig. 5). The transported excavator, as the police findings showed, probably was stolen from another building site, which explains the driver's unusual determination to ram all the obstacles on his way. Luckily at this time, the vehicle traffic on the road was relatively light, there were no construction workers on the scaffolds, no casting work was being conducted, and so there were no casualties.

Therefore, after the first vehicle struck at the girders of the scaffold situated immediately above the road clearance (conforming to the technical documentation approved by the highway supervision authority), the headroom was increased by the available reserve (by redesigning and rebuilding the load-bearing structure of the scaffold). This, however, did not help much since soon another vehicle hit the lower part of the scaffold located directly above the drive-through. After the second vehicle strike, the designers of the scaffold together with the viaduct builder had to increase the vertical clearance. They decided that the minimum safe vertical clearance in this case should be 4.30 m. At this clearance no more vehicle strikes occurred. The scaffolds and the new vertical clearance were tried out on another viaduct, i.e. WD-19. The vehicle, which previously damaged the scaffold of WD-14 this time, drove through.

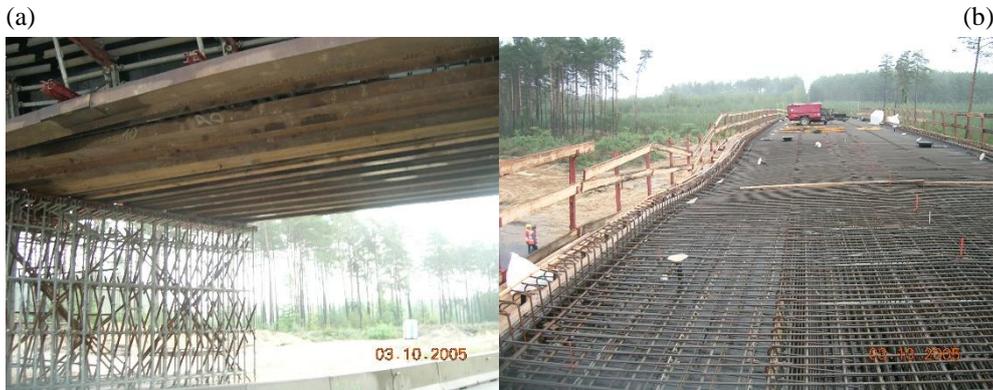
Fig. 5. View of viaduct WD-12 scaffold after vehicle strike: (a) damaged and turned steel girders of scaffold (two girders on Wrocław side were turned), (b) collapsed reinforcement of span load-bearing structure before planned casting.

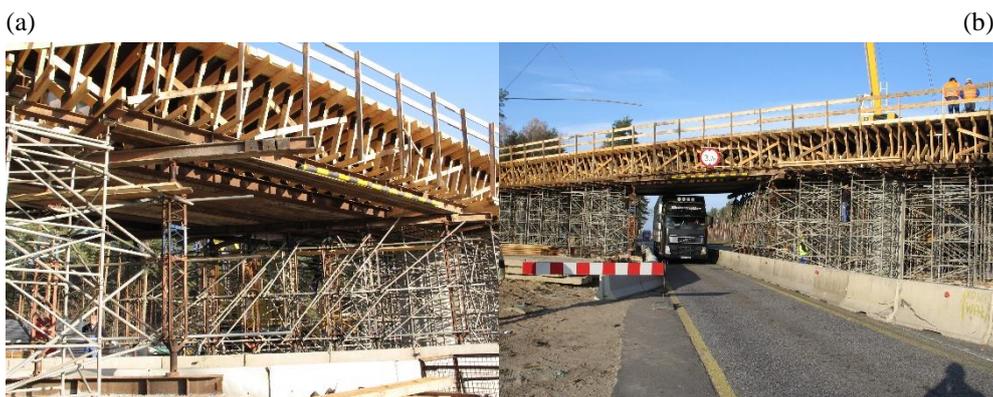
Fig. 6. Side view of encased scaffold of viaduct WD-14 prior to superstructure casting after two vehicle strikes into girders located above clearance: a) H20 scaffolds erected under formwork, b) drive-through clearance outline shifted to edge of roadway.

In the case of viaduct WD-14, two vehicle strikes into steel girders located above the drive-through clearance occurred whereby the contractor and the designers had to redesign the scaffold structure several times.

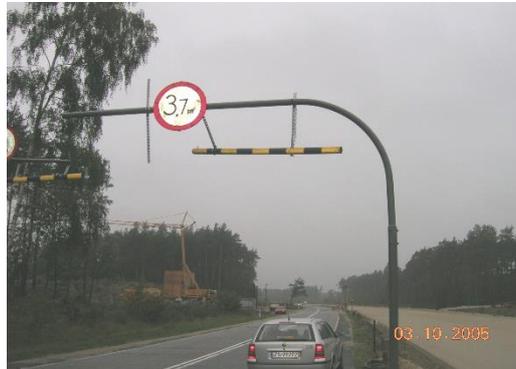
Fig. 7. View of beam marking height of clearance (3.70 m) before entry into the road section where scaffolds were being erected and reinforcement installed prior to casting spans (vertical clearance for all viaduct being built was 4.20 m and was larger than clearance height on warning gate where there was exit leading to another road).

Until the proper amendments are adopted, half-measures must be used, and, in the cases where the height of the drive-through clearance cannot be increased above 4.20 m, unbreachable solid drive-through gates and warning systems should be erected – such as audible and visual signalling devices warning drivers early that their vehicles exceed the height of the drive-through gate located in front of the road structure. It should be added that, if all the above possibilities have been exhausted, one should contact the road services which must screen vehicles and direct the ones with excessive height to previously prepared diversions.

Regardless of the increased road height clearance and additional protections (Fig. 7), it should always take into account the fact that, because of some irresponsible road users, there is a real possibility that the scaffold will be damaged.
