THE PROBLEM OF SCAFFOLDS FAILURES DURING THE CONSTRUCTION OF NEW VIADUCT OVER HIGHWAY

Daniel KAŁUZIŃSKI ¹⁾, Zbigniew MAŃKO ²⁾, Arkadiusz MORDAK ³⁾

Using as example highway viaducts WD-14 and WD-12 built over national road A-18 being upgraded, the failures of the scaffolds erected to build on site the concrete objects are described and their causes are explained. The cases considered here and the ones presented previously [1, 3, 4, 5, 8, 9, 22] clearly show the need to modify and update the guidelines for erecting scaffolds for the building of road bridge structures. This applies particularly to the minimum headroom as vertical clearance since the current standard one is inadequate. The above considerations should be taken into account in the designs of bridge structures.

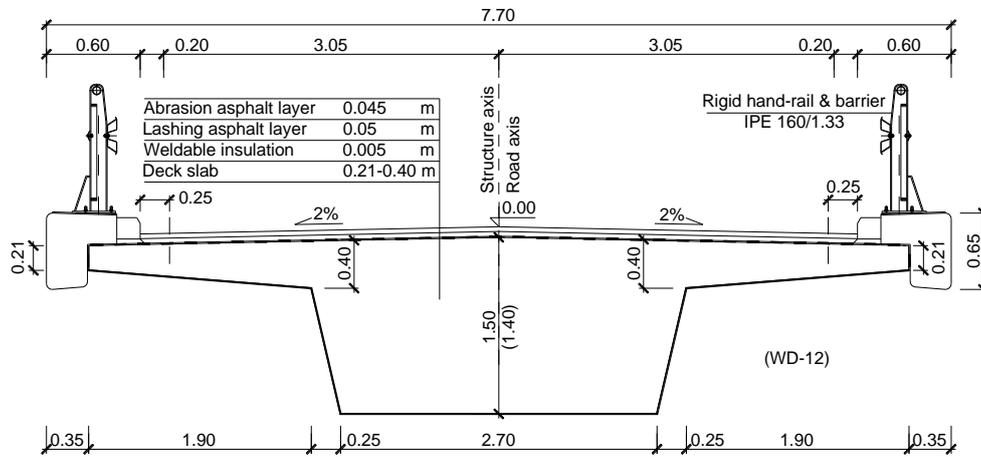
Fig. 1. Cross-sections of viaduct WD-14 and WD-12 (dimensions for the latter are given in brackets).

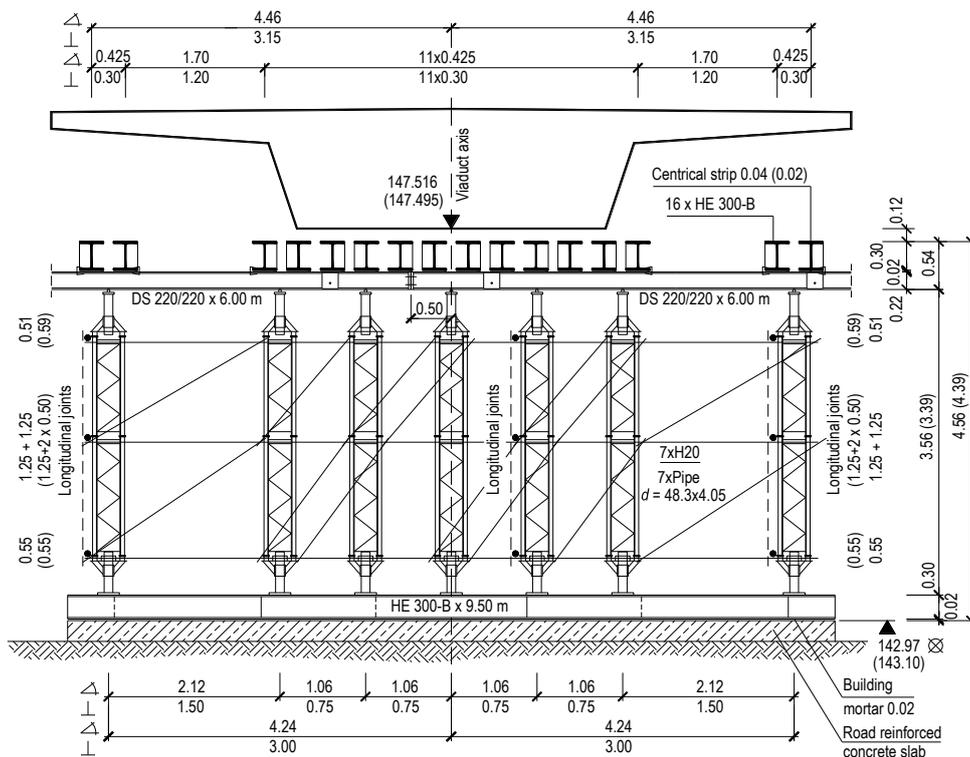
Fig. 2. Cross-section of viaduct WD-14 with structure of scaffold put up above road clearance.

The spans situated directly above the road clearance were supported by heavy scaffolds H20 type on which double-T steel girders were put up (Fig. 2).

After the second vehicle had stricken into the increased from 4.20 m to 4.26 m vertical clearance, it became necessary for safety reasons to redesign the height of the drive-through gate. A detailed analysis of the causes of the damage to the scaffold showed that replacing the HE-B 300 girders with shorter ones was out of the question because of the insufficient load-capacity of any shorter girders. It was found, however, that it was possible to reduce the height of the formwork trusses situated immediately above the clearance from 0.10 m to 0.06 m. In addition, because of the roadway cross fall of 2%, the whole drive-through gate was moved to the edge of the roadway towards the lowest road grade line whereby a few more reserve centimetres were obtained (Fig. 6). In this way, a vertical clearance of 4.33 m was obtained at the lowest point of the road 4.36 m at the edge of the clearance, i.e. by 0.13 m larger than the standard clearance of 4.20 m and by 0.07 m larger than the other clearance of 4.26 m (Fig. 3d). The new drive-through height of 4.33 m ensured safe work on the viaduct until its completion.
